ARMOR AND ORDNANCE REPORT NO. A-117

OBSERVATIONS ON THE PERFORATION OF SLABS OF
PLASTIC PROTECTION BY SMALL-CALIBER AP PROJECTILES

# NATIONAL DEFENSE RESEARCH COMMITTEE ARMOR AND CRDNANCE REPORT NO. A-147 DIVISION 2

OBSERVATIONS ON THE PERFORATION OF SLABS OF PLASTIC PROTECTION BY SMALL-CALIBER AP PROJECTILES

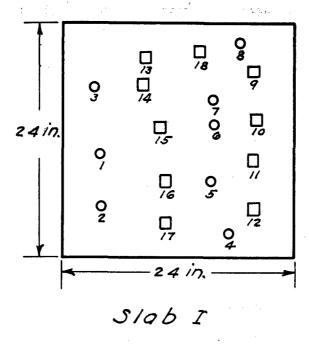
Fig. 1. Shot points for slabs described in Sec. 2. Round numbers: 0, for caliber .30; 0, for caliber .303.

The relative positions of the shot points are shown to scale in Fig. 1, the shots being numbered consecutively in the order of firing. Although the slabs were found to be uniform in thickness to ± 1/16 in., it was thought that any possible effect of systematic variations in thickness from side to side would be minimized by thus interspersing alternate rows of the two projectiles.

Of possibly greater significance was the fact that some shots pushed the steel backing plate away slightly from the plastic armor. This was usually restricted to the immediate vicinity of the bulge and with the spacings as shown in Fig. 1, probably did not affect other shots.

35	Shallow smooth impression in the backplate. About half a core, including the base, was found in one piece in the plastic protection which bulged toward the plate, but probably no fragments hit the backplate.
36	Rough hole in backplate with yaw. No part of core found.
<b>37</b>	Several small pits in the backplate. The backplate is known to have been pulled away from the plastic armor before this shot; knocked away by shot No. 32. Figure 1 shows that shot No. 37 hit quite near No. 32.
